日本大学生産工学部 鉄道工学リサーチ・センタ 特別シンポジウム
「国際協調による鉄道安全性向上の取り組み」

Railway Accident Investigation and Safety Improvement in Taiwan 台湾における鉄道事故調査と安全性の向上

Yung-Cheng (Rex) LAI / 賴勇成
Railway Technology Research Center
  National Taiwan University

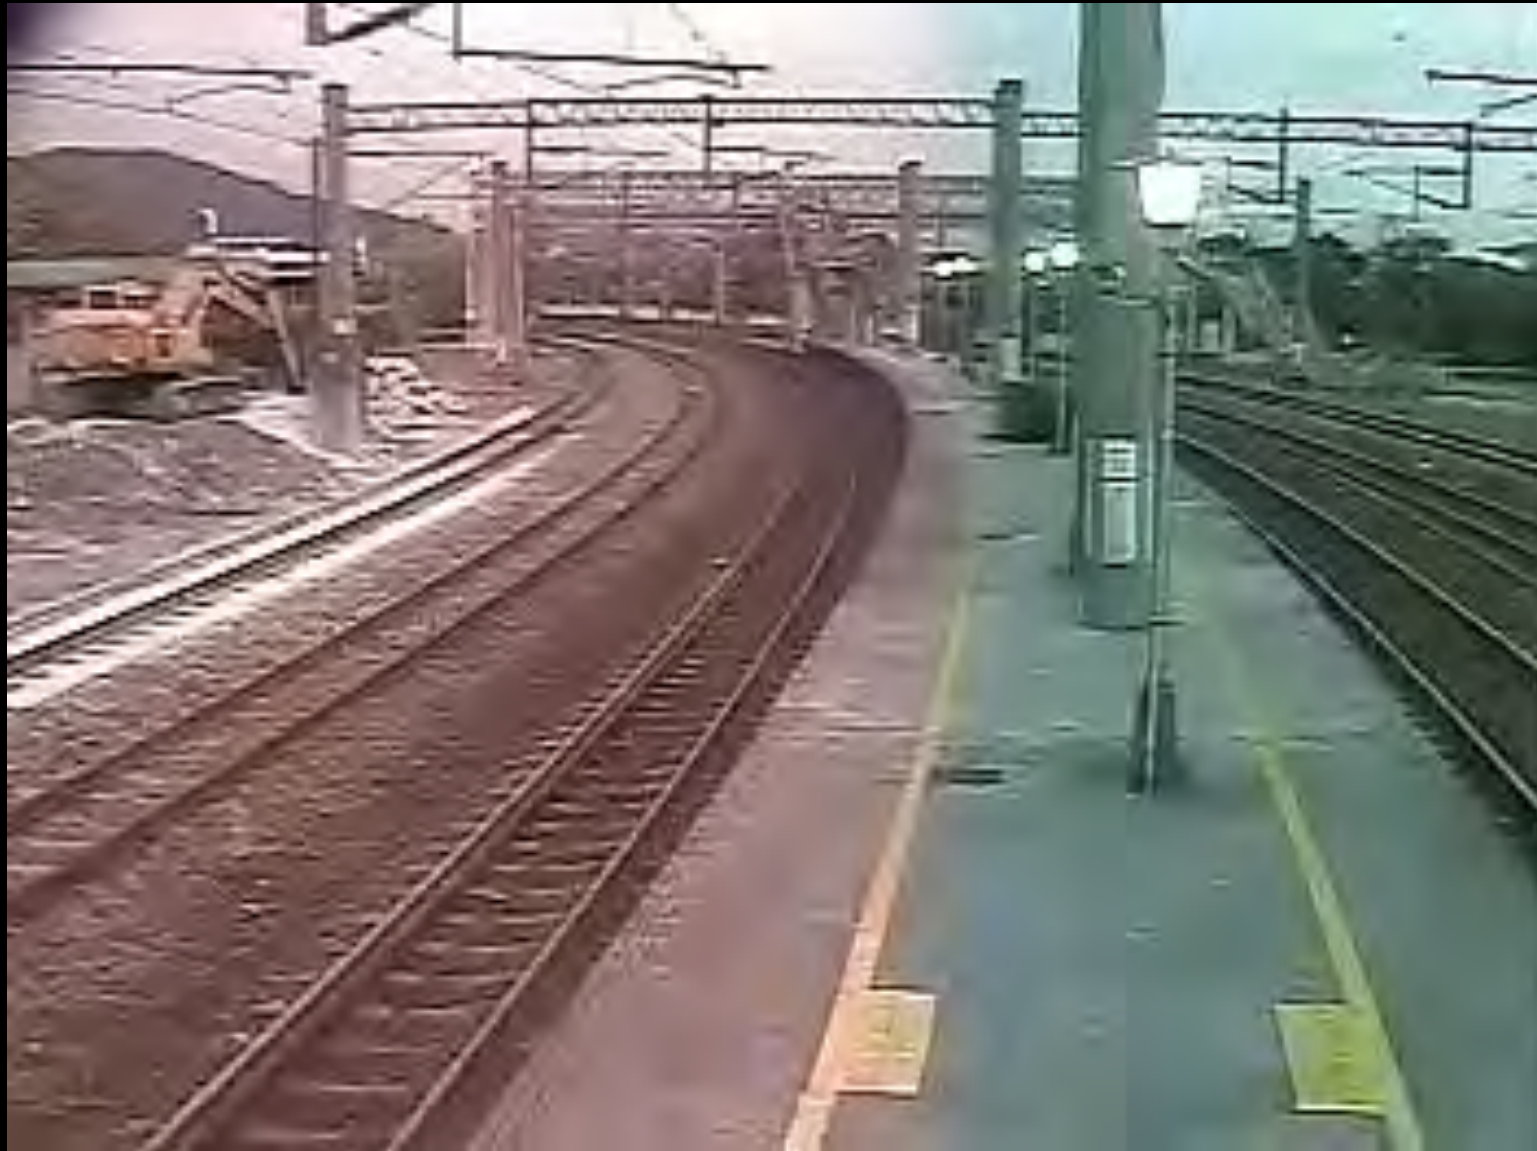
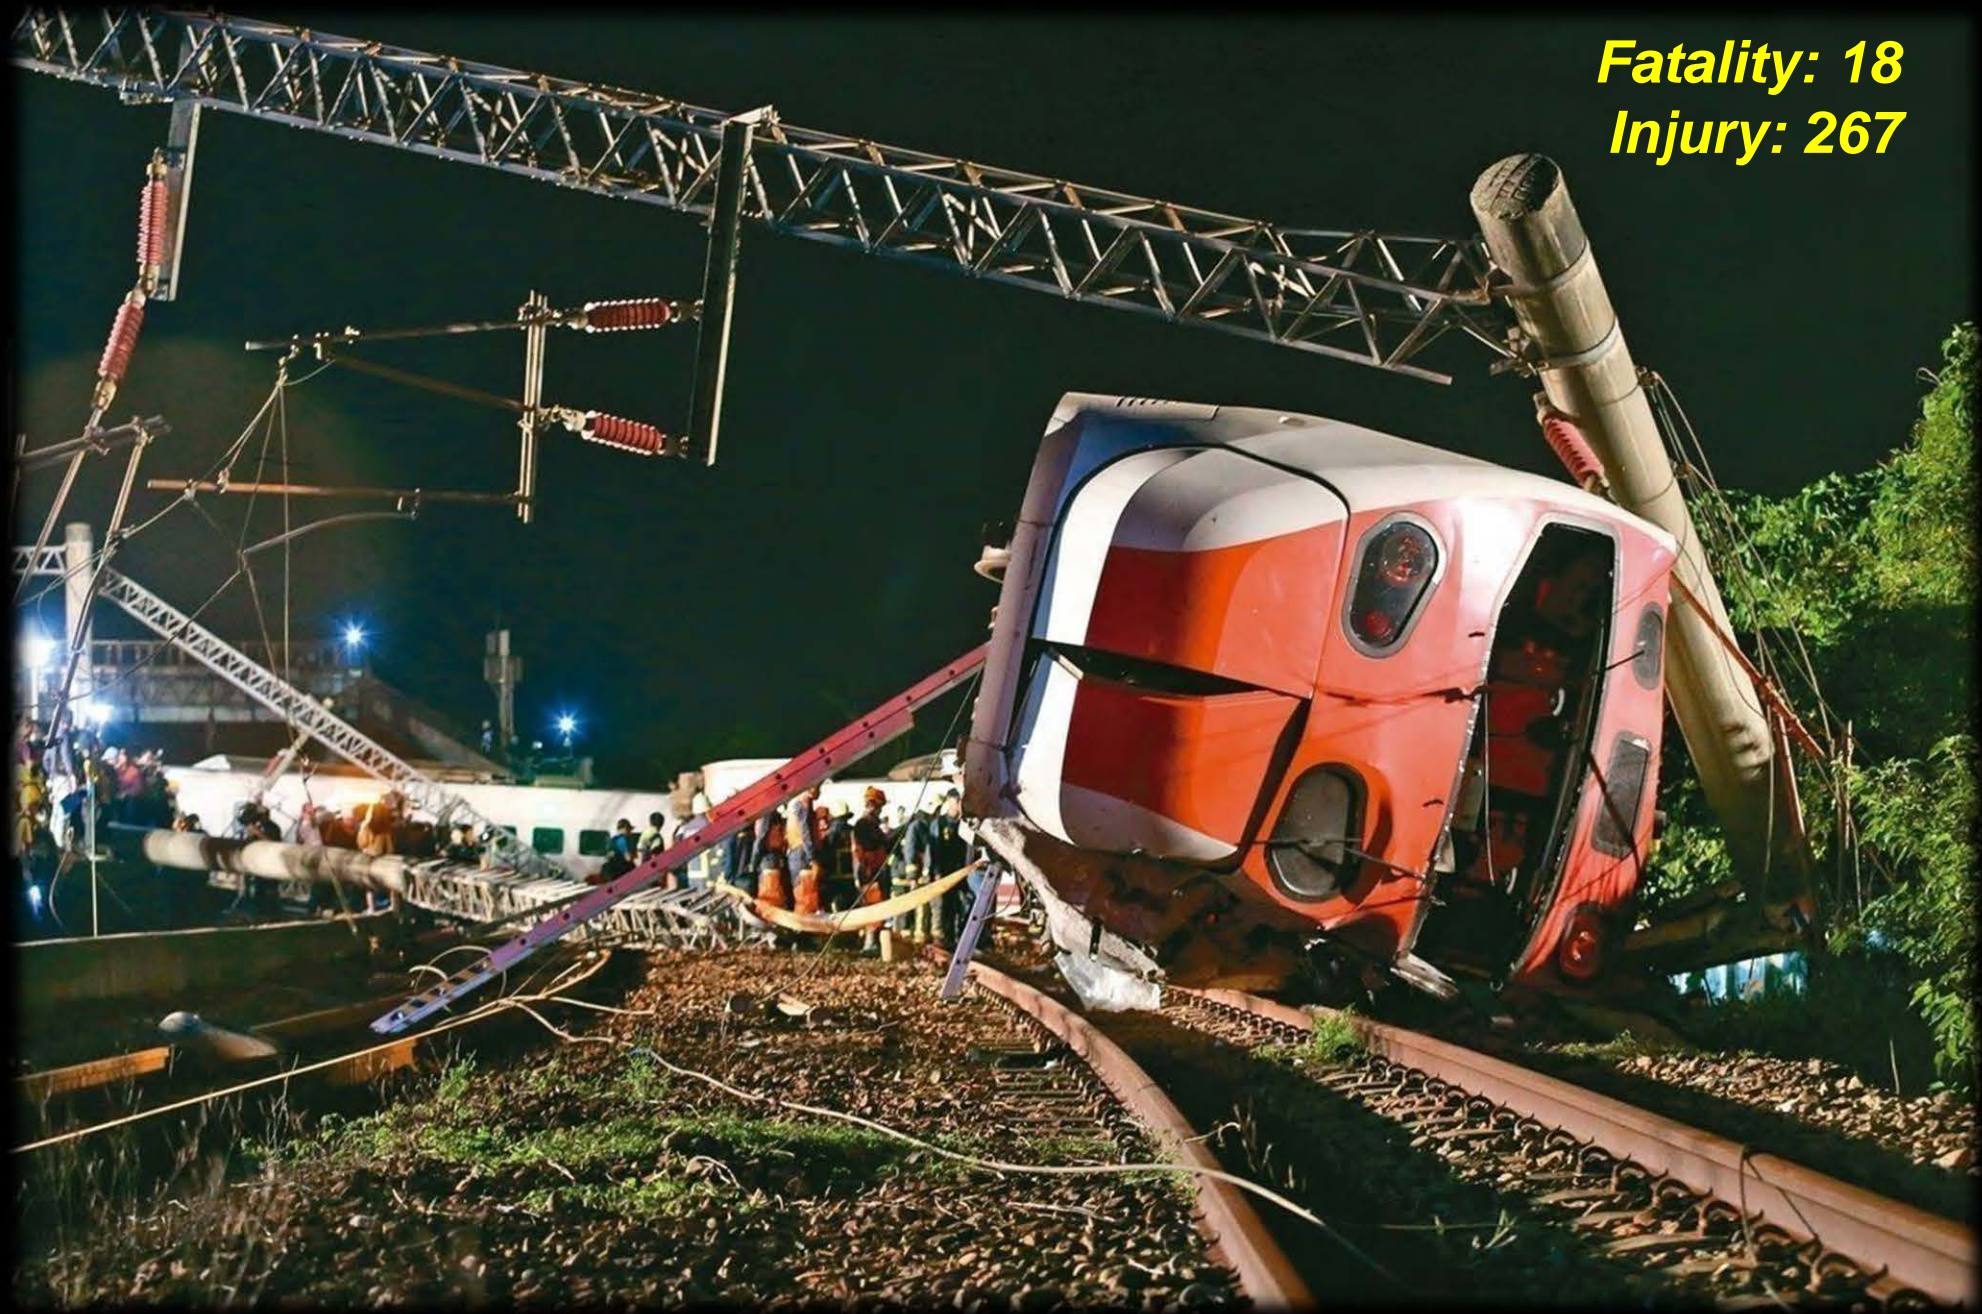
Oct 21st, 2018

Fatality: 18
Injury: 267

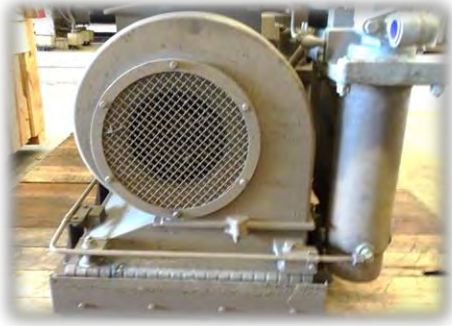
Main Compressor

- Generate **compressed air** for braking, air springs (to support tilting), horn, door operations, etc.
- Puyuma has **4 compressors** per train-set, and the generated compressed air would be storage in the **Main Reservoir (總風缸)**

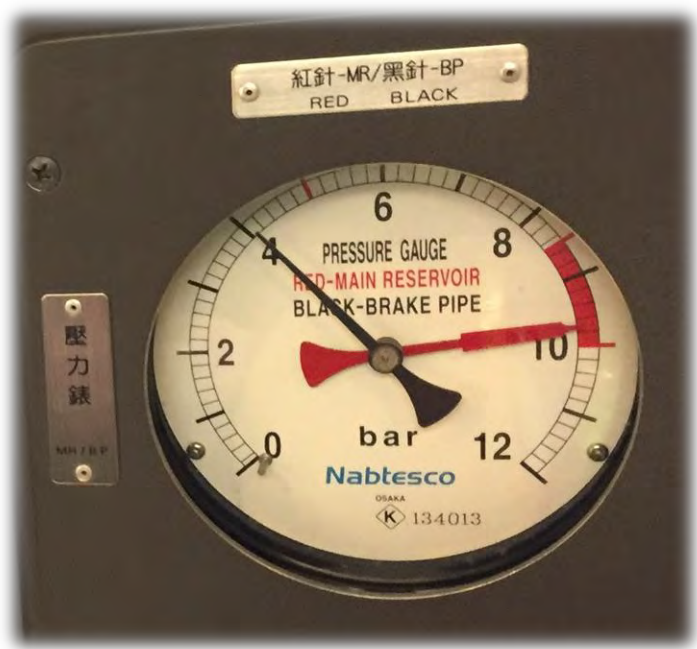
主風泵失效自趨安全設計 Fail to Safe (MR)

In order to avoid insufficient compressed air for braking, when the MR pressure is less than **5.5 bar**, the train will forcibly cut off the power. If the MR pressure is less than **5.0 bar**, the train will be forced to stop.

~ 10 bar
(Normal)

< 5.5 bar
(Automatic Cut
Traction Power)

< 5 bar
(Automatic Stop)

> 6 bar
(Power Resume)

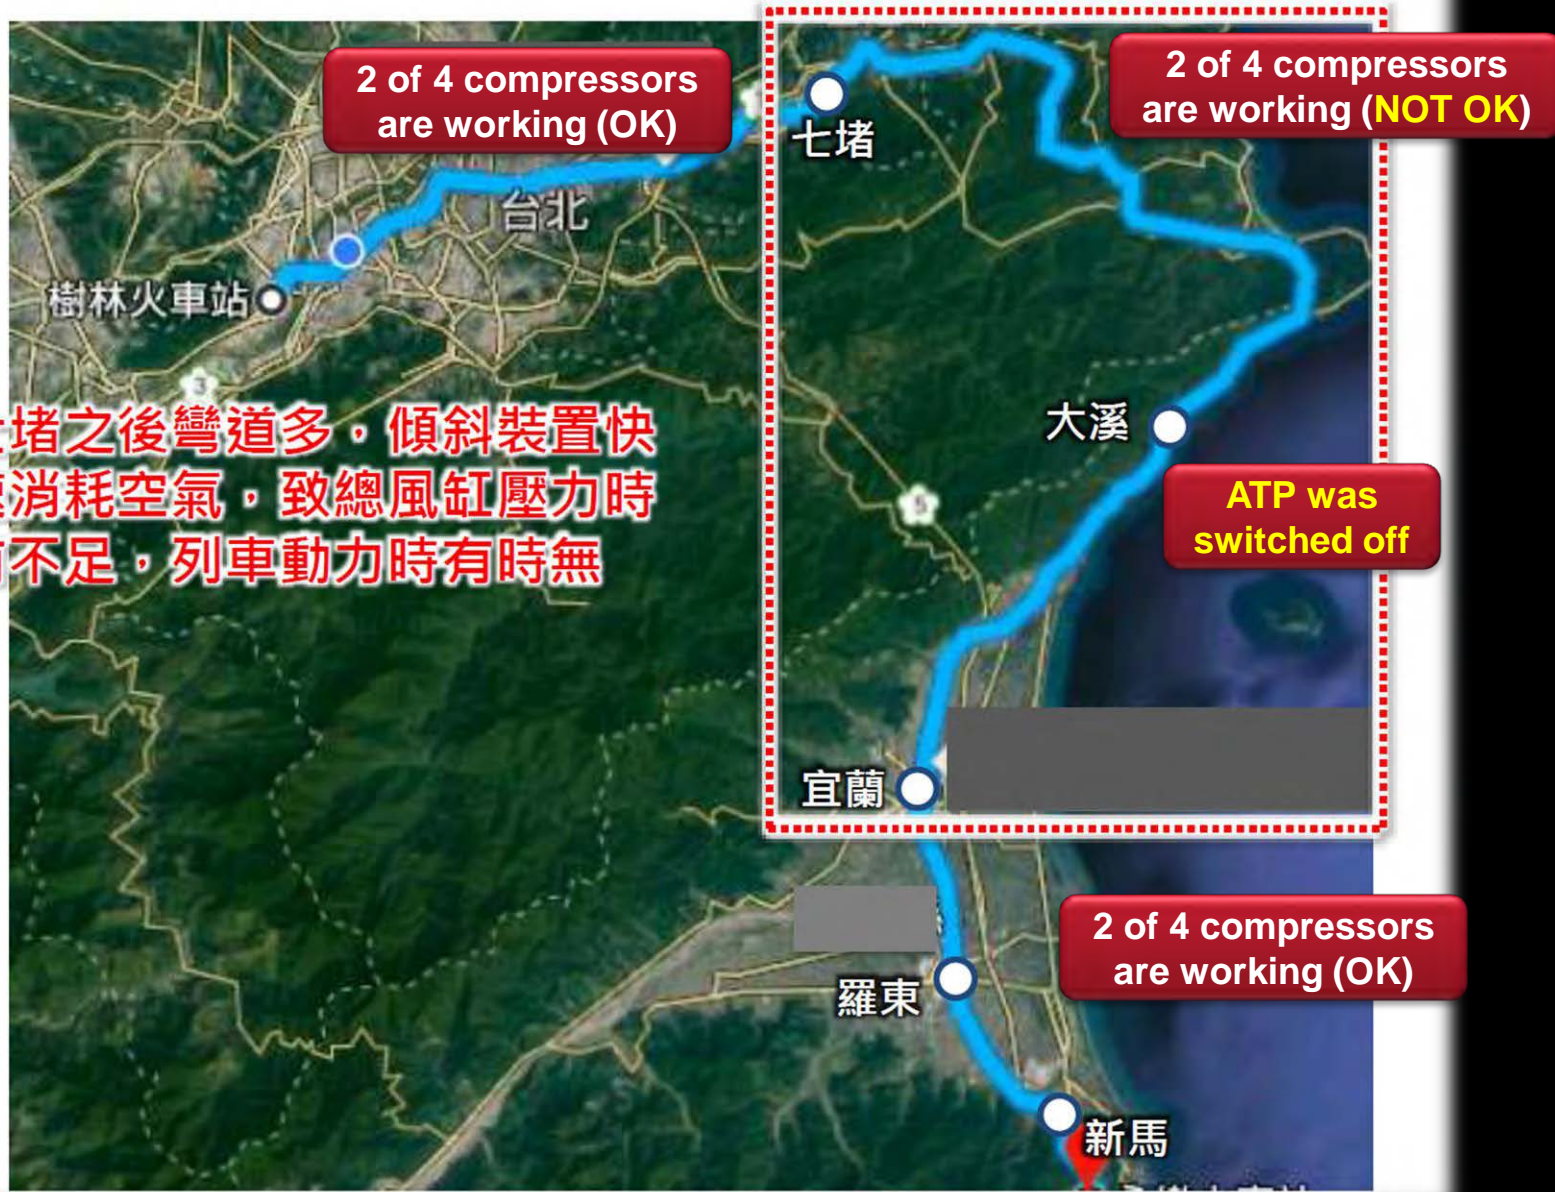
七堵之後彎道多，傾斜裝置快速消耗空氣，致總風缸壓力時有不足，列車動力時有時無

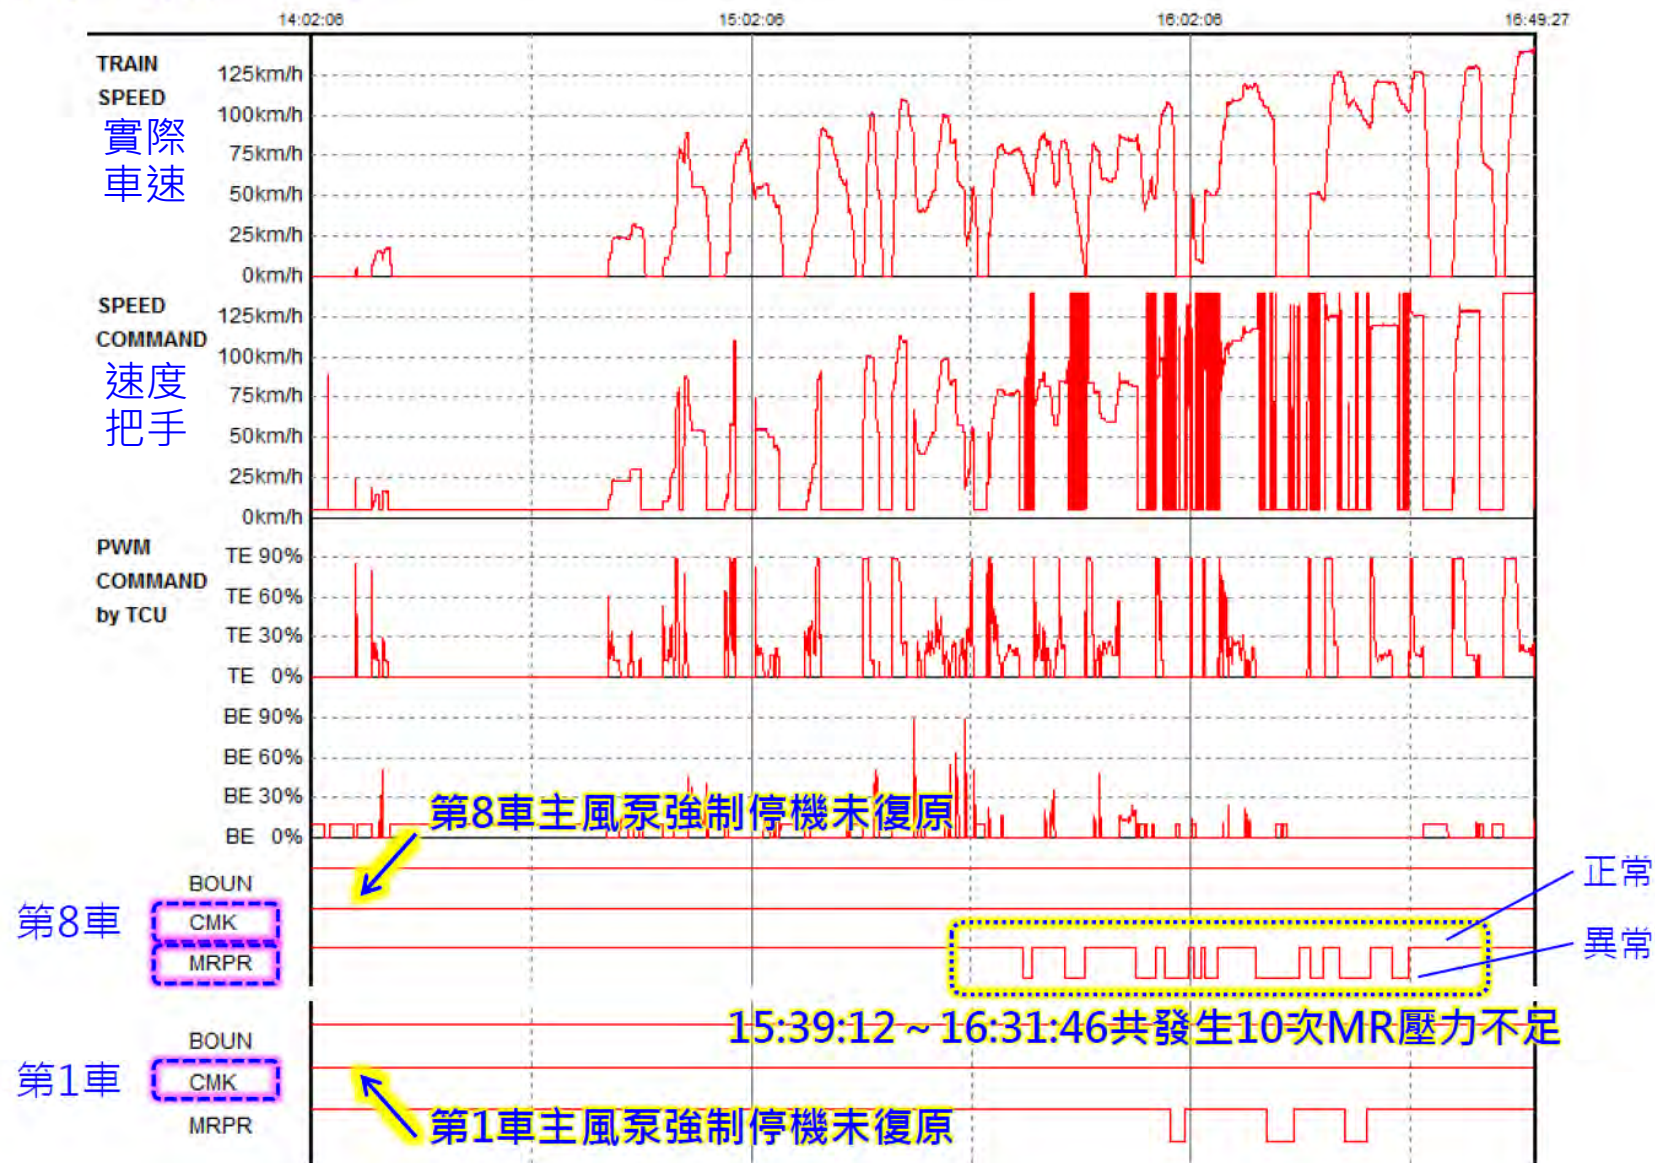
TCMS紀錄 - 第6432次列車主風泵運作狀況

運行方向：樹林→新馬

事故列車行進中，因 **主風泵異常**，發生列車動力時有時無、停留軀機間歇作動之異常狀況，**相關人員採取之運轉決策及應變處置作為未排除異常狀況**；司機員於列車行進中，同時**持續通聯嘗試排除列車異常狀況**，進入新馬站彎道前未依規定減速。

During the operations, the train were subject to abnormality of the compressors, resulting in power lost and unintentional train stops. None of the driver, dispatchers, and maintenance crew could clearly identify the problem and successfully resolve this abnormality. At the same time, the driver, who were continuously communicating with other railway personnel in order to solve the problem, did not apply brake before entering the curve.

1. 檢討 **ATP隔離** 操作、通報及隔離訊號之監視與確認，要求落實執行
Review SOP for ATP system / Enforce speed limit while switching off ATP
2. 儘速完成普悠瑪列車ATP隔離開關 **遠端監視線路接線** 及測試
Ensure the ATP remote monitoring system are functioning for all rolling stock
3. 會同日本原廠儘速查明 **主風泵異常根本原因**，徹底改善
Identify the causes and solutions to the overheating problem of the compressors
4. 執行普悠瑪 **列車特檢**，並加強主風泵保養、清潔或更換必要組件
Examine all Puyuma train-sets, especially for the compressors.
5. 事故路段搶修後之 **軌道平整** 改善、**擋碴牆** 復原並確認 **護軌** 長度足夠
Ensure the appropriateness of the track restoration after the accident

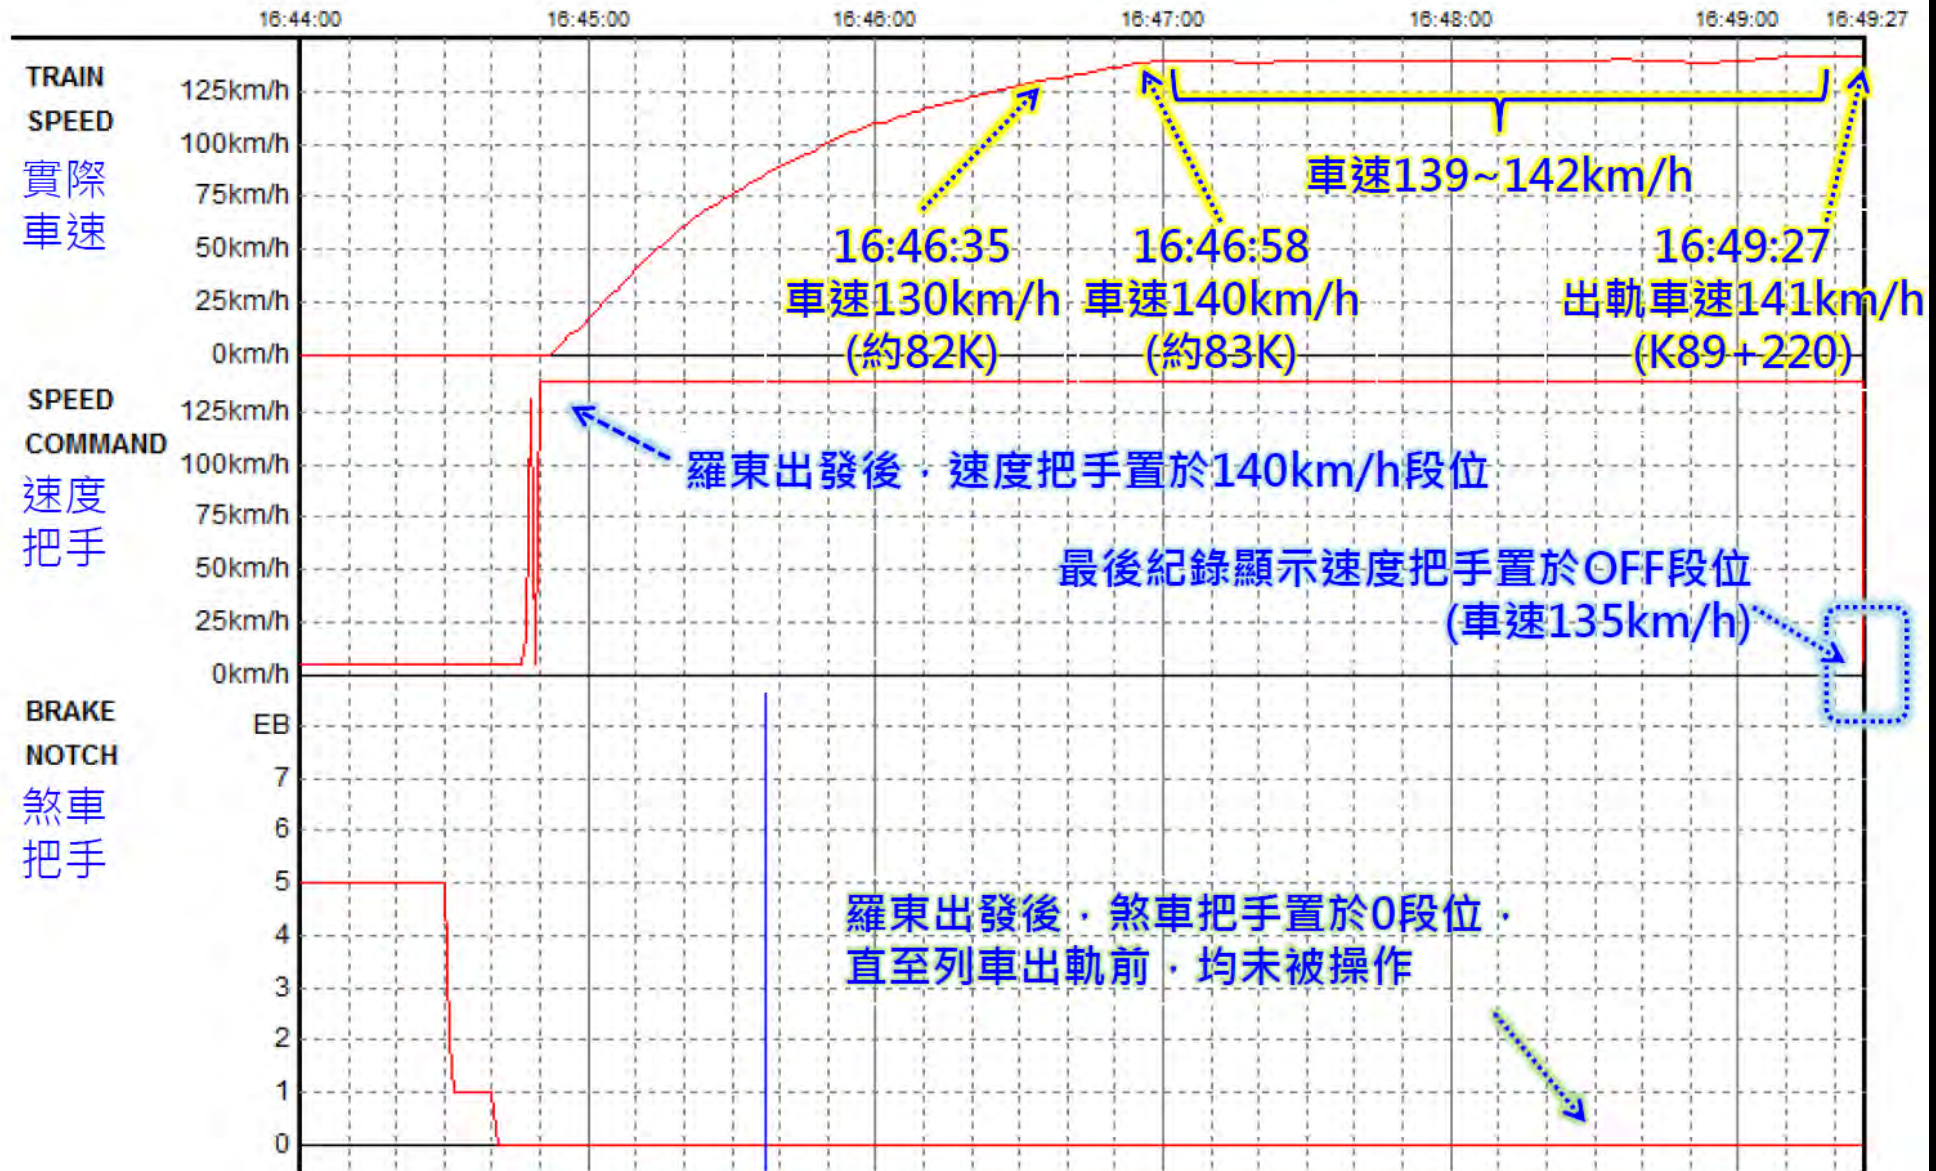
TCMS紀錄 - 出軌前車速及速度/煞車把手位置

事故列車以 **超過速限(75km/h)的速度(141km/h)**進入半徑306公尺的新馬站彎道，致列車前進方向第1節車廂右側車輪浮起後出軌並向左側傾覆，隨後第2至8節車廂也相繼出軌。

The accident train entered the 306-meter curve right before Xinma Station at 141 km/h, exceeding the speed limit (75 km/h), causing the train to derail.

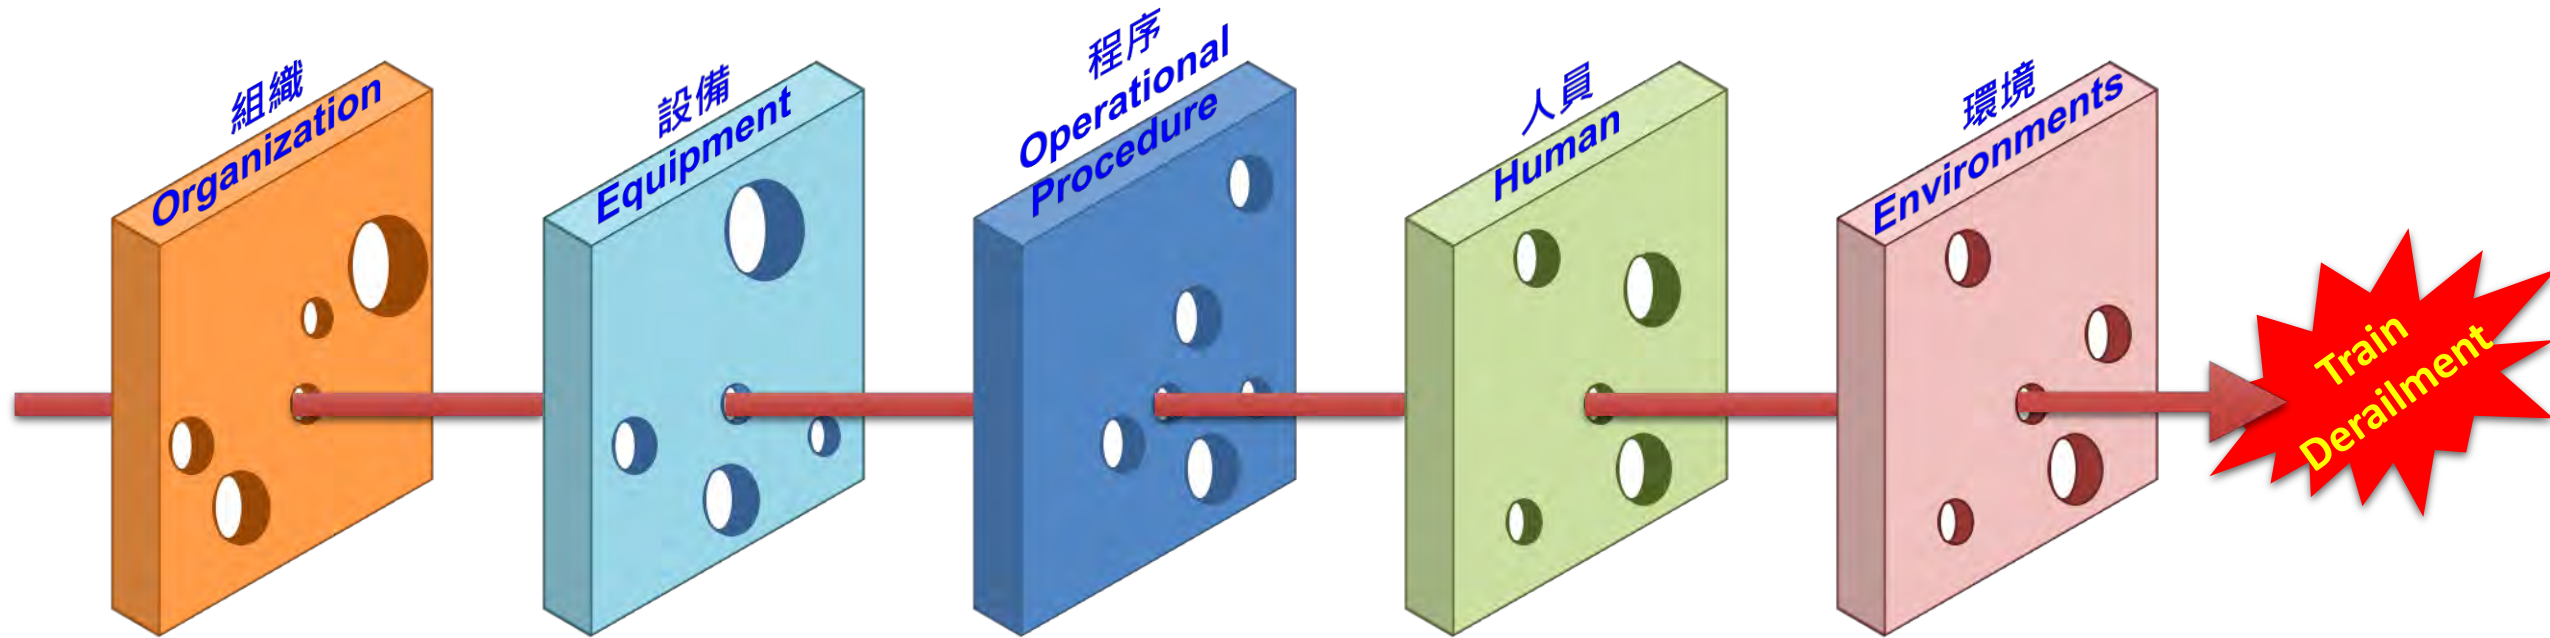
圖 4.2.1-4 故障樹(4/4)

- Inappropriate safety management & safety culture
- Insufficient training on troubleshooting
- Failure in the acceptance process for ATP remote monitoring system

- Overheating problems in the compressors
- Problems in the ATP remote monitoring system

- Communication procedure and languages were not standardized
- Lack of standard troubleshooting procedure
- SOP for switching off ATP is questionable

- Fail to recognize actual cause of problem
- Fail to follow the SOP for switching off ATP
- Overspeed

- Driving under anxiety
- Curved route
