日本大学生産工学部 鉄道工学リサーチ・センタ 特別シンポジウム
「国際協調による鉄道安全性向上の取り組み」

Railway Accident Investigation and Safety Improvement in Taiwan 台湾における鉄道事故調査と安全性の向上

Yung-Cheng (Rex) LAI / 賴勇成
Railway Technology Research Center
  National Taiwan University

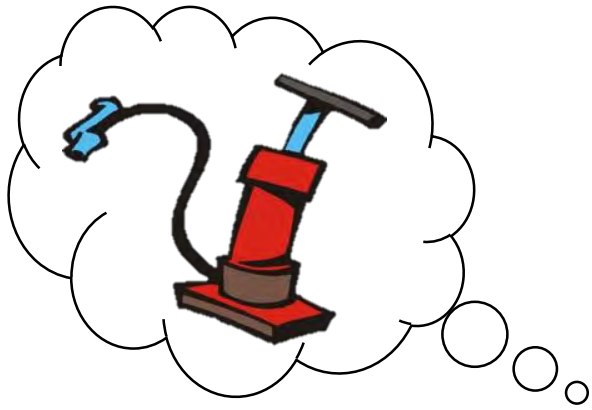
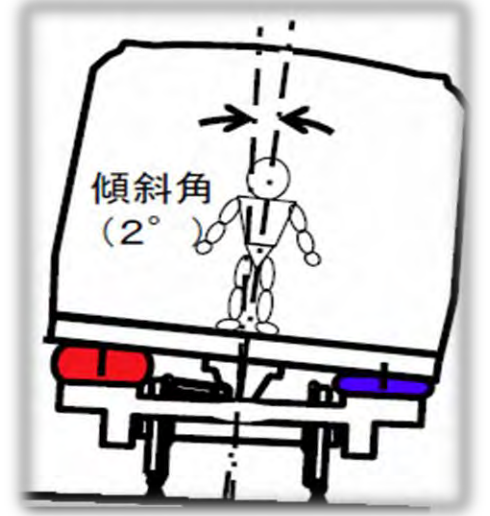
Main Compressor

- Generate **compressed air** for braking, air springs (to support tilting), horn, door operations, etc.
- Puyuma has **4 compressors** per train-set, and the generated compressed air would be storage in the **Main Reservoir (總風缸)**

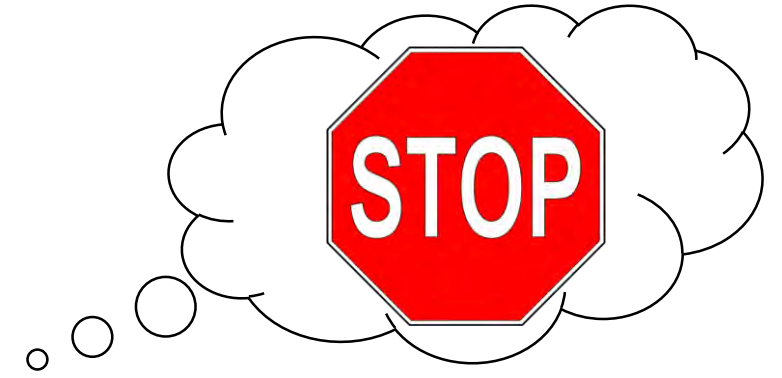
主風泵失效自趨安全設計 Fail to Safe (MR)

In order to avoid insufficient compressed air for braking, when the MR pressure is less than **5.5 bar**, the train will forcibly cut off the power. If the MR pressure is less than **5.0 bar**, the train will be forced to stop.

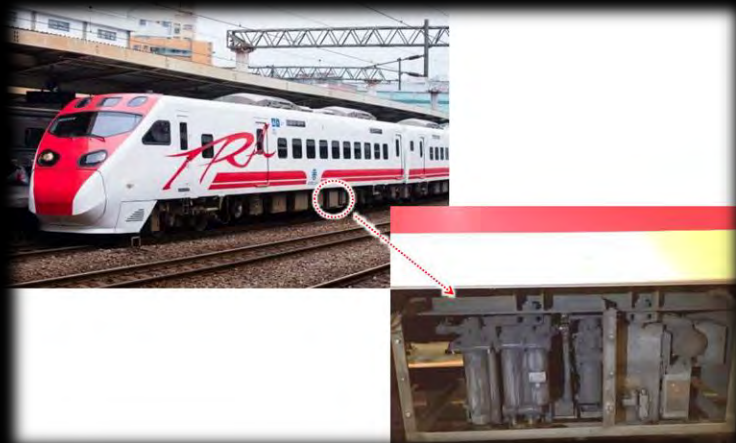
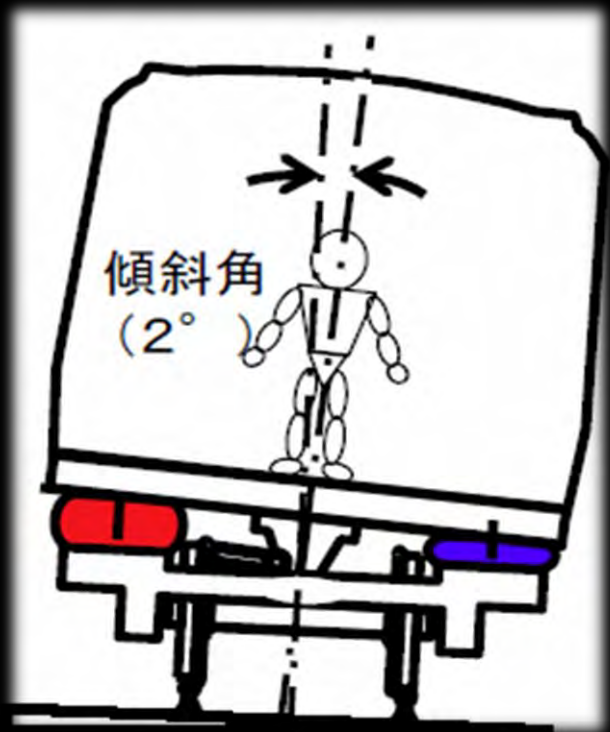
第6432次列車行駛路線

七堵之後彎道多，傾斜裝置快速消耗空氣，致總風缸壓力時有不足，列車動力時有時無

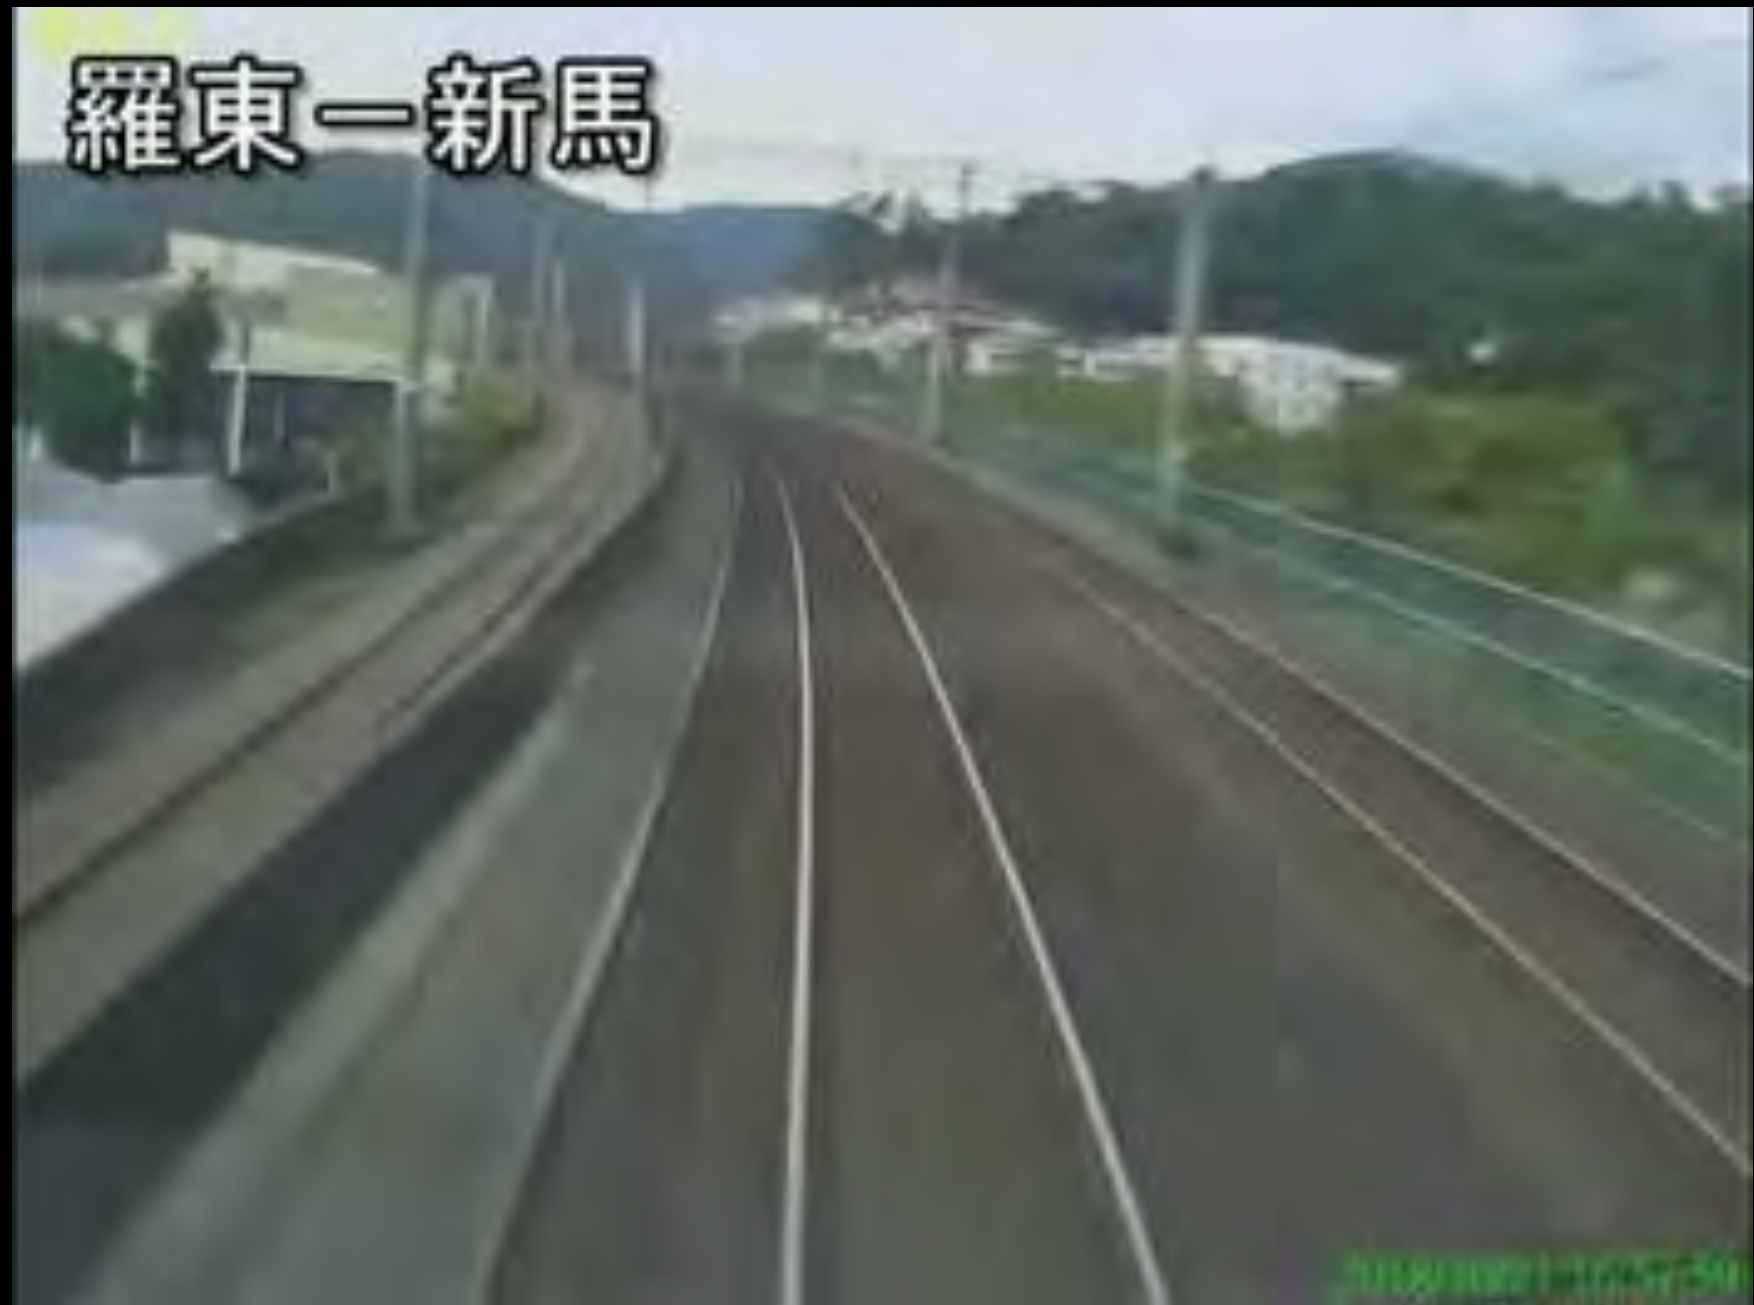
TCMS紀錄 - 出軌前車速及速度/煞車把手位置

事故列車以 **超過速限(75km/h)的速度(141km/h)**進入半徑306公尺的新馬站彎道，致列車前進方向第1節車廂右側車輪浮起後出軌並向左側傾覆，隨後第2至8節車廂也相繼出軌。

事故列車行進中，因 **主風泵異常**，發生列車動力時有時無、停留軀機間歇作動之異常狀況，**相關人員採取之運轉決策及應變處置作為未排除異常狀況**；司機員於列車行進中，同時**持續通聯嘗試排除列車異常狀況**，進入新馬站彎道前未依規定減速。

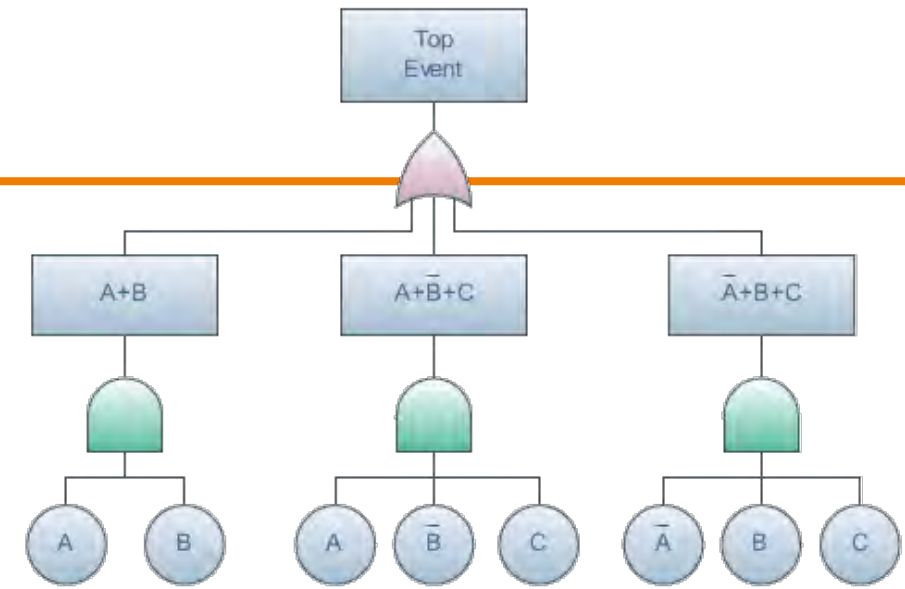
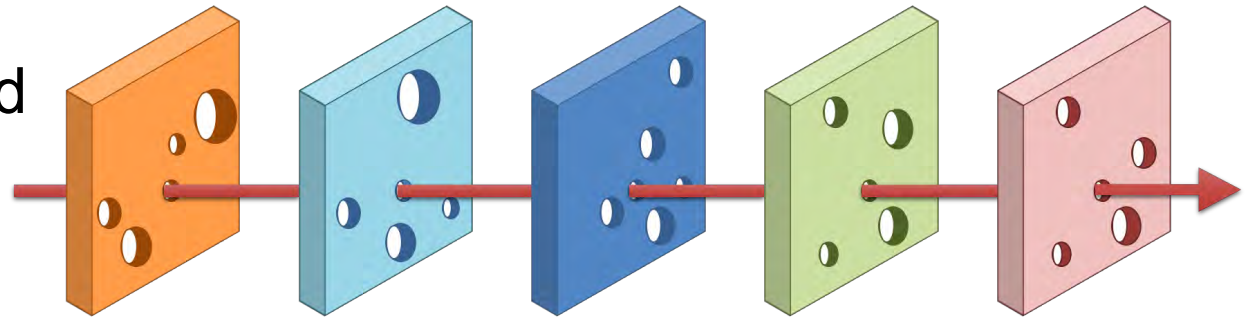
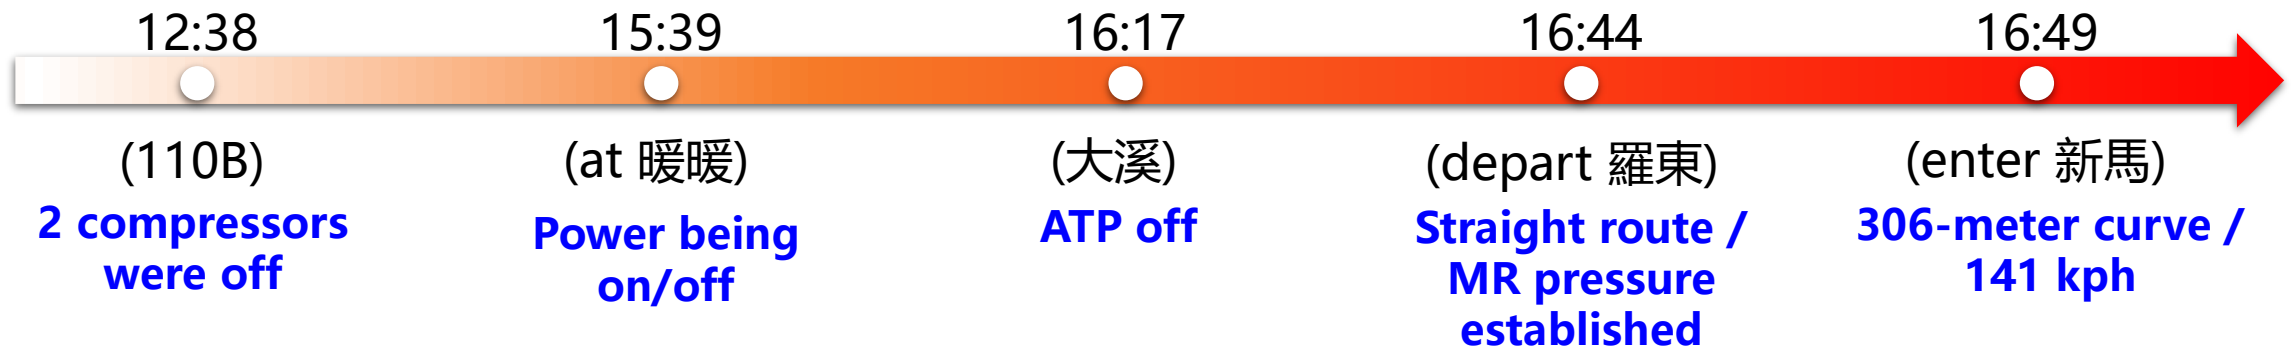
Fault tree for 1021 Accident

- ▶ **Fault tree analysis (FTA)** were used to identify the direct and indirect causes
- ▶ **Swiss cheese model** were also used to categorize and present the causes
- ▶ A graphical output of **time-sequence Swiss cheese figure** is also proposed and used to present the accident investigation results
